ZOO INTERCHANGE REDUCED IMPACTS ALTERNATIVE MILWAUKEE COUNTY:

ROAD SAFETY AUDIT

FINAL REPORT

December, 2011

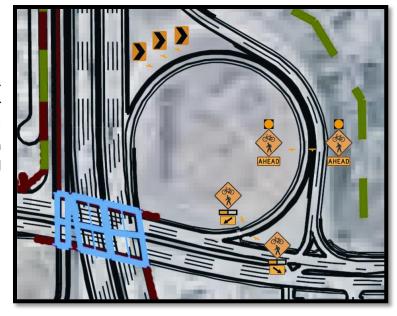
The free-flow loop ramps at both Wisconsin Avenue and North Avenue create a safety issue for non-motorized road users at these locations. Free-flow ramps are designed to reduce delay and increase mobility among motorists. Free flow loop ramps pose a potential risk to non-motorized road users as a result of the lack of traffic control devices available at this type of juncture. The extreme speed differentials between pedestrians and motor vehicles are likely to result in serious injuries. Additionally, in many cases, sight distance is also limited as a result of the radius of curvature of the loop ramp.

Expected Crash Types: Pedestrian, bicycle

Expected Frequency: Occasional

Expected Severity: High

Risk Rating: E (high risk level)

Alert motorists to the potential for nonmotorized road users to be crossing near the ramp terminal by installing warning signs. Consider installing pedestrian crossing warning signs with attached flashing beacons.

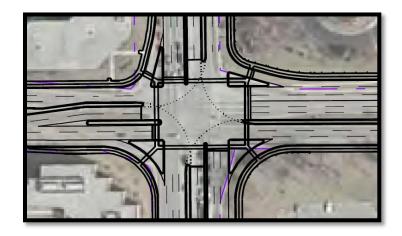
Channelized right-turn lanes, such as those pictured below, can be found throughout the study area. Channelized right-turn lanes decrease delay for motorists by creating a yield controlled intersection allowing for motorists to maintain both speed and momentum when gaps in oncoming traffic present themselves.

This ease-of-use enhancement for motorists creates a potential safety issue for non-motorized road users. Pedestrians and bicyclists attempting to cross the channelized right-turn may not be in many drivers sight-triangle. Additionally, pedestrians may not have the ability to move quickly enough to clear the crosswalk given the higher speeds of vehicles utilizing this lane. Elderly drivers, or those with limited mobility, may have increased difficulty maneuvering their bodies to check for oncoming traffic over their shoulders.

Expected Crash Types: Pedestrian, bicycle, elderly

Expected Frequency: Occasional

Expected Severity: High

Risk Rating: E (high risk level)

Consider converting all of the 45°/45°/90°-style (see; southwest and southeast islands as shown above) channelization islands to 30°/60°/90°-style (see; northwest and northeast islands as shown above) channelization islands. This adjustment will, while maintaining the efficient yield control, require that drivers reduce their speeds by a larger margin as a result of the change in geometry of the intersection. Additionally, pedestrians and bicyclists will be in a position more visible to motorists.

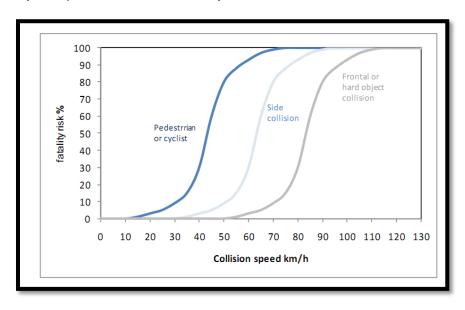
The Reduced Impacts Alternative design proposes a bicycle lane into the plan for STH-100 between IH-94 and Watertown Plank Road. Given the projected traffic volumes and the current 45 M.P.H. speed limit on this roadway, the potential for serious bicycle/motorized vehicle interaction to occur is high.

Expected Crash Types: Bicycle

Expected Frequency: Frequent

Expected Severity: High

Risk Rating: F (extreme risk level)

Consider revising the Reduced Impacts Alternative design to remove the proposed bicycle lanes from STH-100. An alternative may be to create a shared-use path where-in both bicyclists and pedestrians can share a single space set back from the roadway. A shared use path is a safer alternative to and inroad lane as the potential speed differentials between a bicyclist and a pedestrian are likely to result in less-severe injuries. Removing bicyclists from the shoulder will significantly reduce the likelihood of serious bicycle/motor-vehicle interactions occurring.

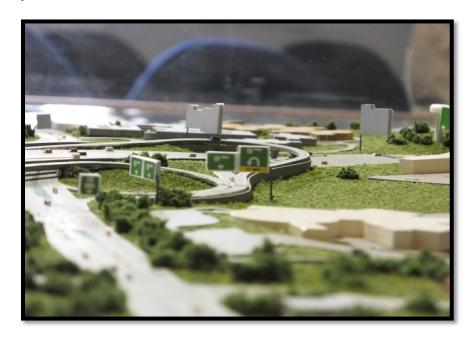
The current signing plan for the Reduced Impacts Alternative Design appears to instruct drivers to perform a u-turn maneuver on the exit-ramp; the proposed sign is non-standard and is not recommended by the MUTCD for this purpose. This misleading u-turn arrow is likely to increase driver confusion and may result in erratic maneuvers.

Expected Crash Types: Head-on, angle-type, rear-end

Expected Frequency: Infrequent

Expected Severity: Moderate

Risk Rating: C (moderate risk level)

Consider removing the u-turn-like arrow from the guide sign. Installing a more standard sign such as a W1-11L will likely reduce driver confusion in this area.

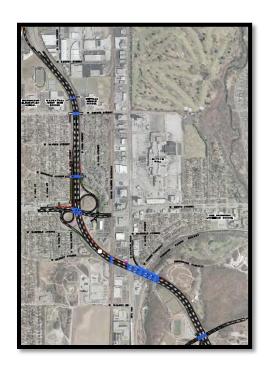
USH-45 between Swan Boulevard and Burleigh Road consists of multiple horizontal curves, Historical crash data and conversations with law enforcement found that median collisions as well as weather related crashes predominated. This may be a result of the current freeway alignment.

Expected Crash Types: Sideswipe, median

Expected Frequency: Occasional

Expected Severity: Moderate

Risk Rating: D (significant risk level)

It is suggested that a high friction pavement surface be installed on the ramps to reduce the risk of sliding under less-than-favorable conditions.

Consider also installing continuous median delineation on the median barrier to aid drivers in negotiating curves under low lighting and inclement weather conditions.

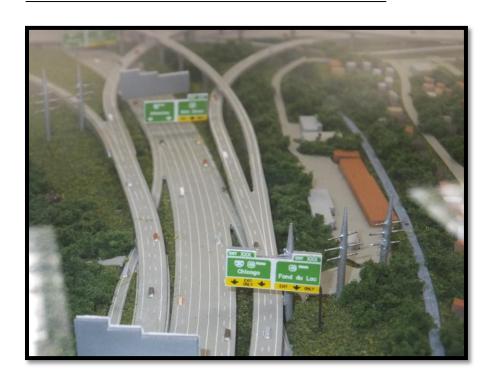
Expected Severity: Low

Risk Rating: C (moderate risk level)

Provide larger radii for the loop ramps from USH-45 to North Avenue. Higher design speeds will reduce the speed differentials associated with tight loop radii. Consider also installing converging chevron pavement markings at the entrance to the loop ramps. Converging chevron pavement markings give the illusion that vehicles are traveling at higher speeds entering into a curve and cause drivers to slow to safer speeds.

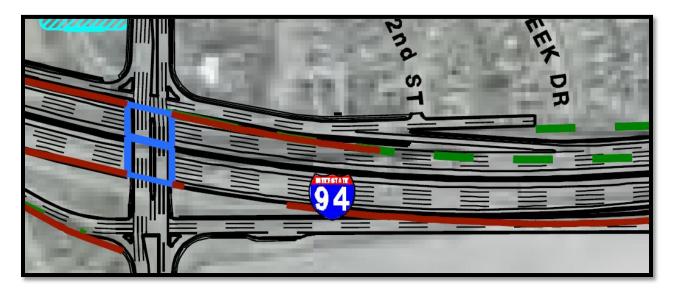
IH-94 at 84th Street, Weave Section

A weave section exists in the Reduced Impacts Alternative Design at the exit-ramp from IH-94 to 84th Street. Motorists intending to head north on 84th Street from westbound IH-94 must merge with traffic from the frontage road and cross two lanes in order to make a right turn.

Expected Crash Types: Sideswipe, weaving, rear-end collisions

Expected Frequency: Occasional

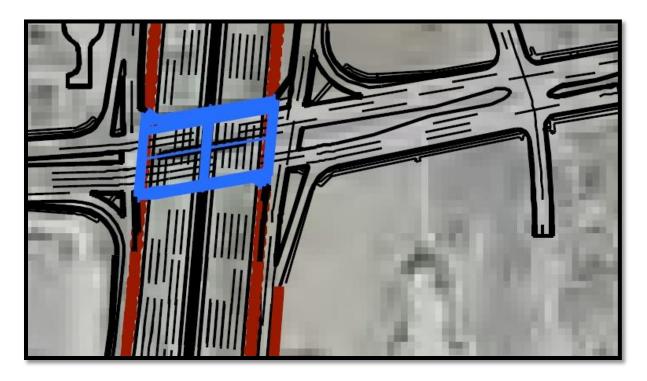
NB USH-45 Exit-Ramp at Bluemound Road

The northbound USH-45 exit-ramp to eastbound Bluemound Road is a free-flow ramp. Free flow ramps pose serious safety issues for non-motorized road users. Please see safety issue number one for more information on free flow ramps. Also, drivers cannot readily utilize the turnaround to head west on Bluemound Road.

Expected Crash Types: Pedestrian, bicycle

Expected Frequency: Occasional
